A R92 million bulk pipeline stretching 5,7 km has been laid to boost the water supply from Pietermaritzburg to Durban by 1 024 litres per second. Umgeni Water, the bulk water provider, needed to improve the water supply to both eThekweni and Msunduzi Municipalities and commissioned Jeffares & Green to design a pipeline to boost the connection from the Midmar Water Treatment Works to World's View Reservoir. The previous system supplied water at a rate of 130 Ml/d but the ultimate design called for a total of 330 Ml/d

Bulk pipeline installation in KZN

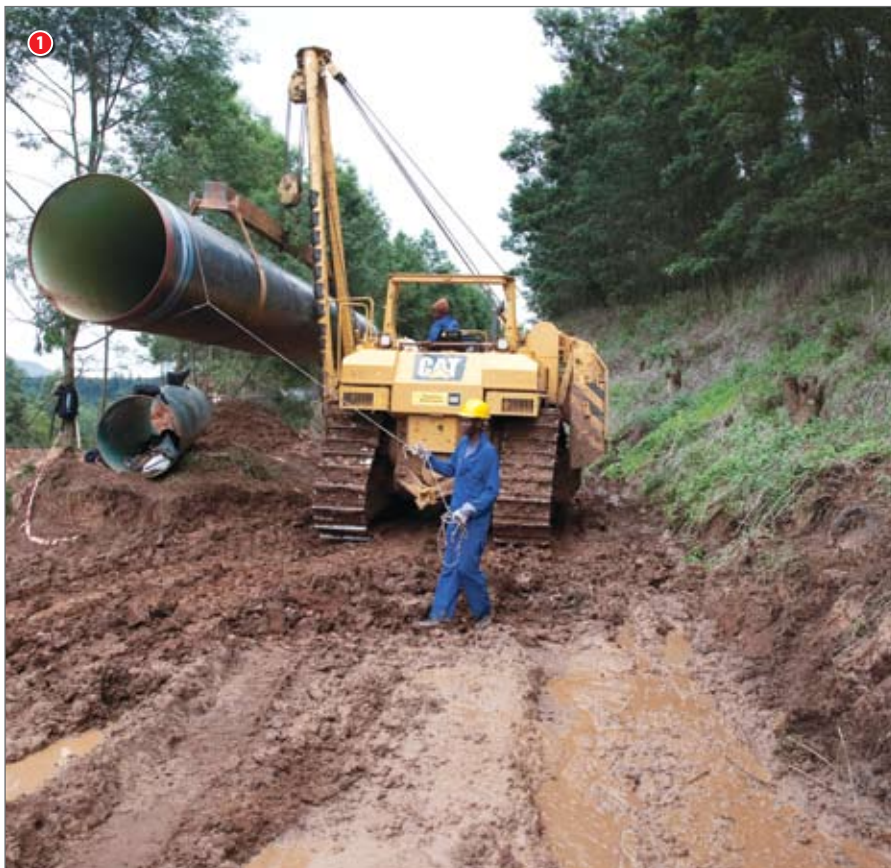
- 1 Heavy rains made pipe laying difficult
- 2 Cut-in and welding at the tie-in at World's View Reservoir

The environmental rehabilitation of the works is being done section by section, and

currently the first 1,4 km section between Ferncliffe and the Victoria Country Club Estate has been top-soiled and revegetated. The balance of the pipeline servitude will be brought back to natural ground level but the grassing and the replanting of rescued plant species will only take place at the beginning of the next growing season, September 2010, as any attempt to get the endemic grass seed to germinate will not be successful before spring. The intention was to have the area shaped, topsoiled and seeded earlier, but construction was

held up by an unusually wet summer in Pietermaritzburg. All rehabilitation measures will be completed by December 2010.

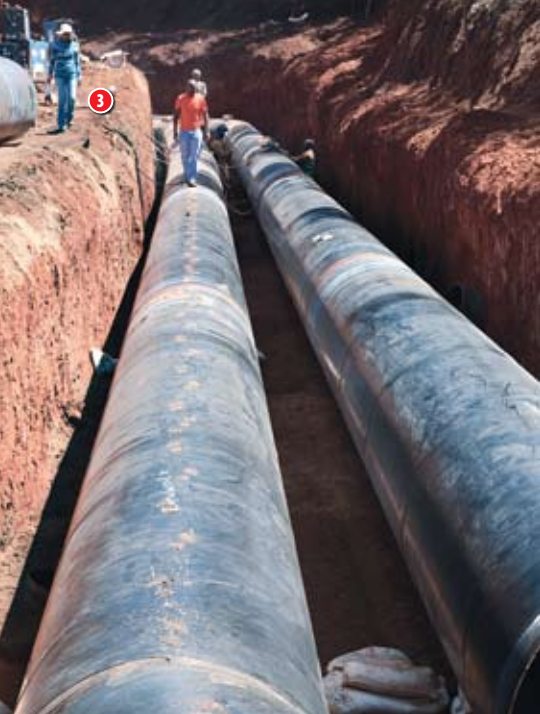
3 Inlet and outlet pipes towards World's View Reservoir

From this point the existing 787 mm diameter and new 900 mm diameter pipelines were conjoined and the new 1 200 mm diameter pipeline was laid over 1 km and connected to the inlet at World's View reservoir. The 1 200 mm outlet followed the same route as the incoming line for 500 m and then deviated to link up with the existing supply lines to Umlaas Road which delivers water to eThekweni Municipality in Durban.

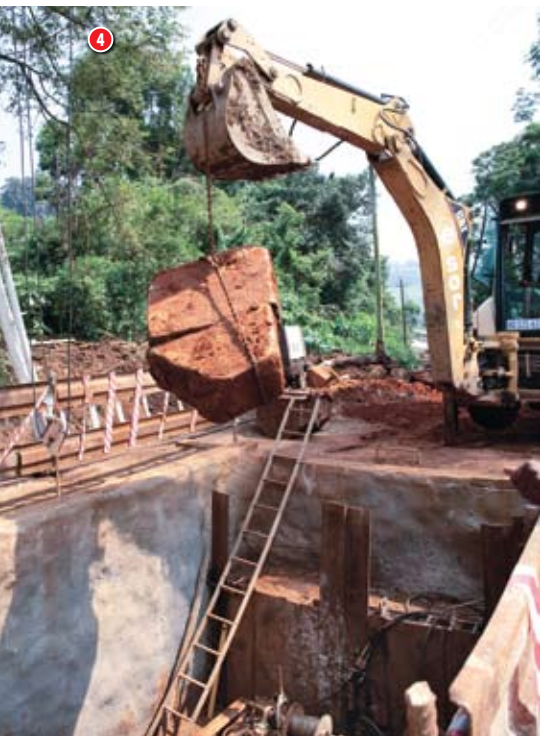
4 Removal of boulders from the pipe jack sleeve

The pipe jacking construction, by Esor Construction, started on 28 January 2009 and was completed on 26 June of the same year. The construction of the jack under the R103 went relatively smoothly with no major setbacks. Rocks were broken up using pneumatic tools or were hauled out of the sleeve using slings and chains. The N3 jack was a totally different scenario. The initial work went well with the establishment of the jacking pit and the insertion of the lead cutting shield.

to raise the level of the N3. Boulders of up to 1,3 m had to be dragged out or blasted into smaller pieces. Inevitably a void started to form above the sleeve as boulders fell in to replace those removed. The excavation was under the northbound fast lane and, as haulage trucks tend to use this lane at night, the additional load and vibration caused further rock movement and it was decided to seal the void with sandbags and to grout behind these. Unfortunately, one rogue boulder was dislodged above the sleeve and demolished the sandbag wall.
