# Cape Town International Airport

## CAPE TOWN INTERNATIONAL AIRPORT – NEW TERMINAL BUILDINGS AND ELEVATED ROADWAY

## Technical Excellence category

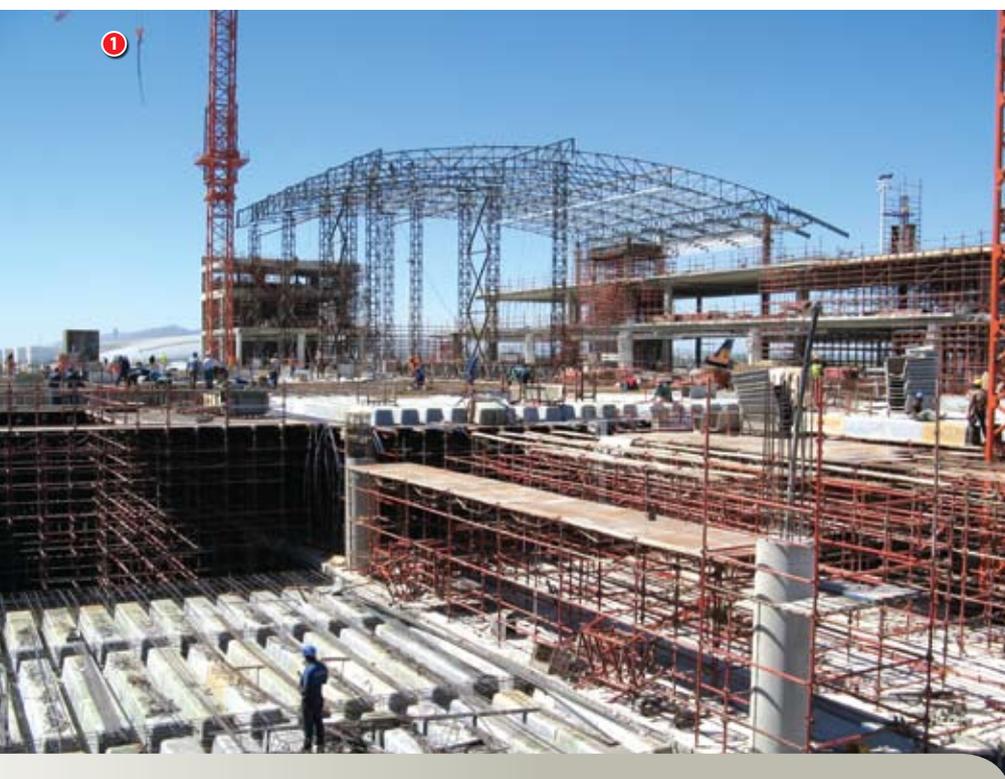
① General view of the central terminal building during construction showing the 525 mm deep troughs for the 625 mm post-tensioned slabs spanning 18 m, and the erection of the roof structure on temporary vertical towers. Also evident behind the support towers is the portion of structure which could not be constructed due to the phased handover of the baggage handling installation

- The suspended floor slabs were constructed using 625 mm deep post-tensioned troughed and coffered slabs. These were required to span the 18 m x 10 m column grid.
- A structural steel feature roof supported on inclined struts to create a strong image and identity reminiscent of 'flying'.

- Various methods were used for both temporary and permanent underpinning to existing structures. These included caissons, driven H-piles and mass concrete.
- The methods of erecting the roof required the main girders to be supported on temporary towers until the inclined struts had been fixed into place.
- Utilisation of the permanent structure to support very high construction loads including mobile cranes. The two western cranes were built through pockets in the suspended slabs. On completion of the roof trusses they were removed. This required the use of a 90 ton crane that was driven onto the elevated roadway and the central terminal building's suspended slab. Special temporary transfer

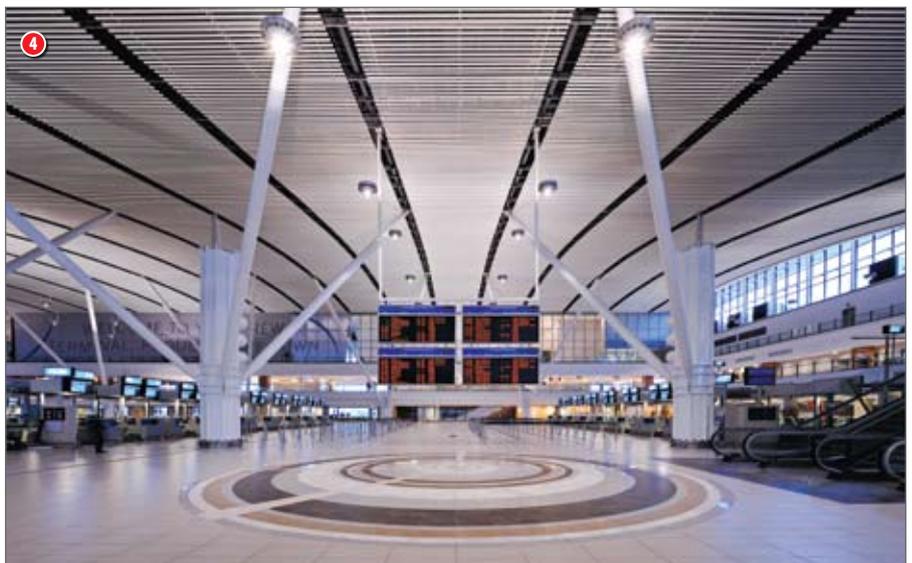
④ General view of the completed check-in hall. The photograph shows the raking supports to the main roof structure, the main support columns with the air shaft and nozzles and the tubular ceiling

- The ceiling to the central check-in building posed a programming and cost problem which was overcome by the use of 65 mm diameter, epoxy-powder-coated aluminium tubes in a grillage to form a ceiling. This option solved the following problems:
  - requirement to commence erection of the ceiling whilst the building was not enclosed
  - acoustic requirements
  - fire requirements
  - aesthetic requirements
- Syphonic rain water disposal system to the main roof.
- Tapered ends to the supporting struts. After investigating all the options for creating a tapered end to the struts, the tapers were formed by pressing two tapered halves and welding them together.
- Steel columns supporting the raking struts. These cylindrical steel columns double as the support for the raking struts and as the air supply duct to the nozzles which feed conditioned air across the check-in area.

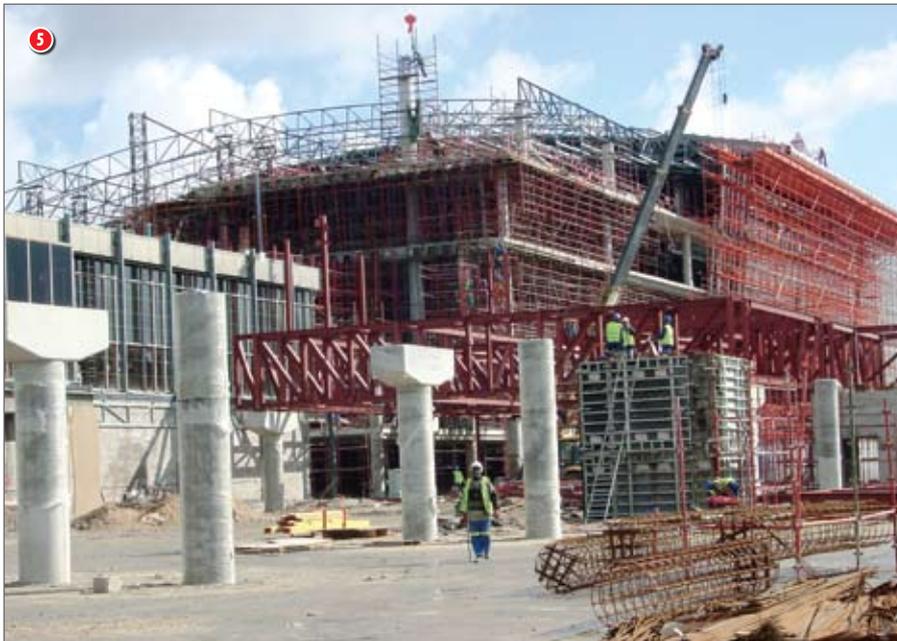
### Airbridges

■ These were constructed of prefabricated structural steel girders which could be lowered into place at night so that the normal operation of the airside road and the apron would not be interrupted.

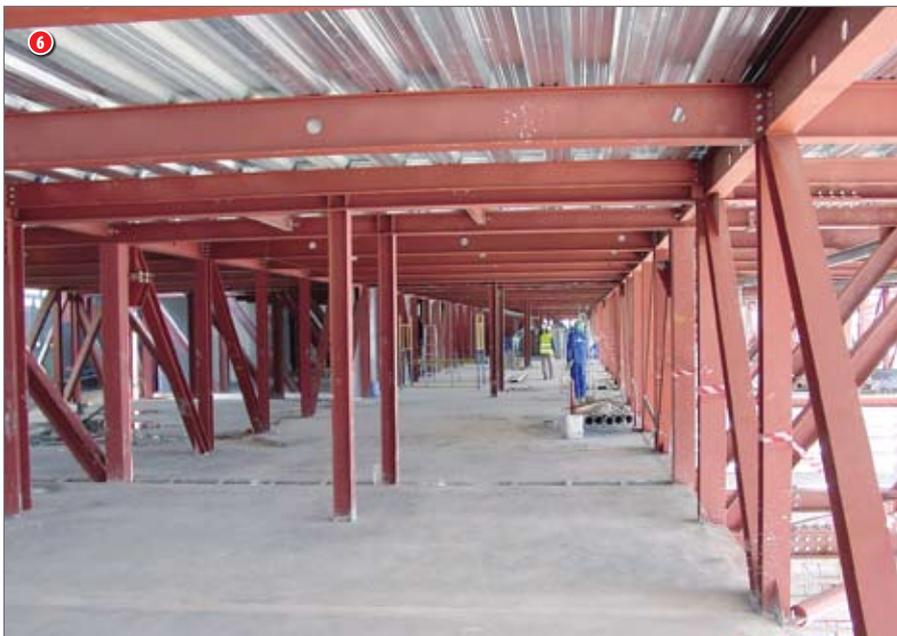
5 General view of the construction of the structural steel domestic departures lounge and arrival corridor over the existing airside road with the central terminal building in the background. The building is supported on the concrete columns in the foreground which allow free access for the vehicles below the building

Designing the new departures lounge in an 'airside' location over the existing airside road meant that the building was subject to geometric constraints. The underside of the structure was subject to a minimum clearance for airside vehicles while the floor levels were dictated by the departing passenger boarding bridge levels.

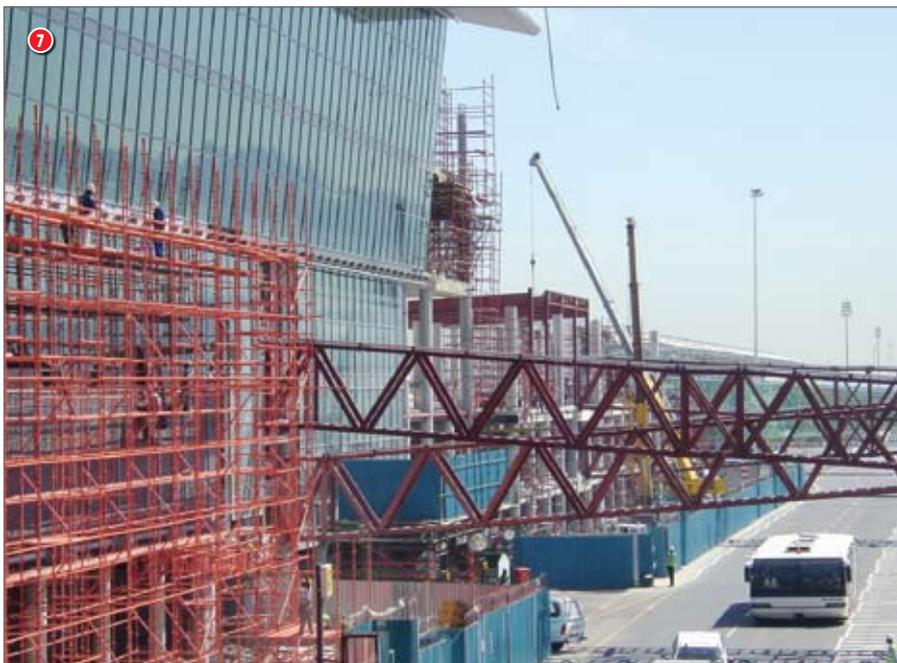
6 The arrivals corridor for the domestic arrivals is contained within the main girders which span over the airside road. This was achieved by locating the corridor within the zone of minimum forces which were accommodated by 'vierendeel' action
