# Nelson Mandela Multi-Purpose Stadium

### Technical Excellence category

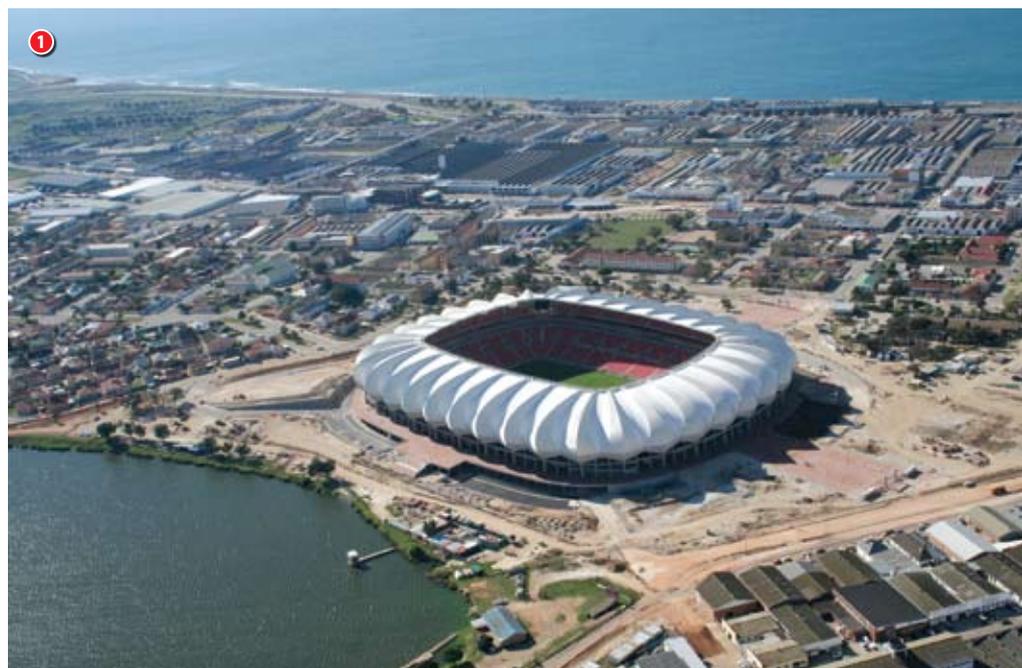
1 The Nelson Mandela Multi-Purpose Stadium is located about 50 m from Port Elizabeth's North End Lake, and within 1 km from the sea

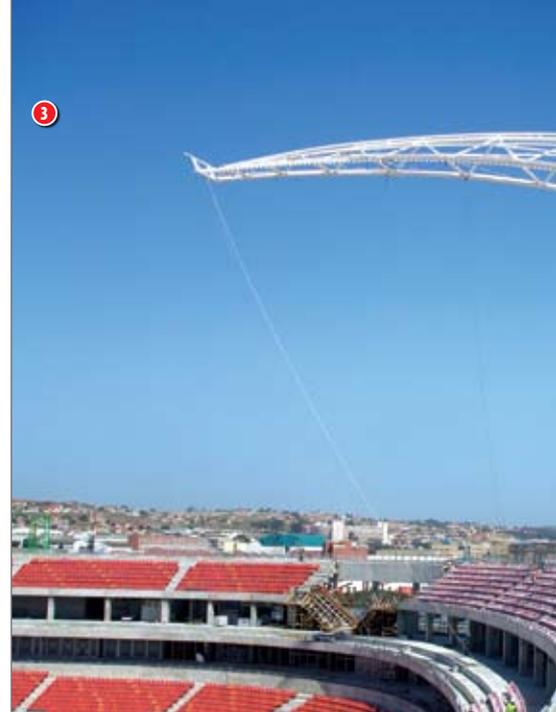
- 2 and 3 and 4 The roof girders were installed entirely from the outside of the stadium. The window of operation for the 500 t caterpillar crane was limited by the notorious Port Elizabeth winds, resulting in the erection of the girders occurring mostly in the morning
- 5 The initial programming sequence required the roof to be erected in a clockwise direction only, but it became necessary to change this sequencing to 30% clockwise and 70% anti-clockwise, resulting in a time-saving of several months
- 6 The roof acquires its remarkable form from the alternating arrangement of the girders and the membrane surfaces spanned in-between

In order to not interfere with the work on and around the playing field, the pre-fabricated girders had to be installed entirely from the outside of the stadium. The pre-fabrication of the girders was performed on scaffolding, which was equipped with individually adjustable clamping saddles to accommodate the different girder geometries. After the calibration of the scaffolding, mobile cranes lifted the pre-fabricated units into place, where they were bolted. The tip of the girder was set in place as a single unit at the end. To compensate for the tolerances from fabrication and the bolt-hole clearance of the connections, the girder tips were initially set in the specified

The window of operation for the 500 t caterpillar crane was limited by the maximum wind speed of 10 m/s. As such wind speeds occur daily in Port Elizabeth, often already before noon, the erection of the girders occurred mostly in the early hours of the morning. The installation of the aluminum cladding proved equally challenging in these windy conditions.
