# St Helen's Rock Pump Station, Umzimkhulu Water Scheme

## OVERVIEW

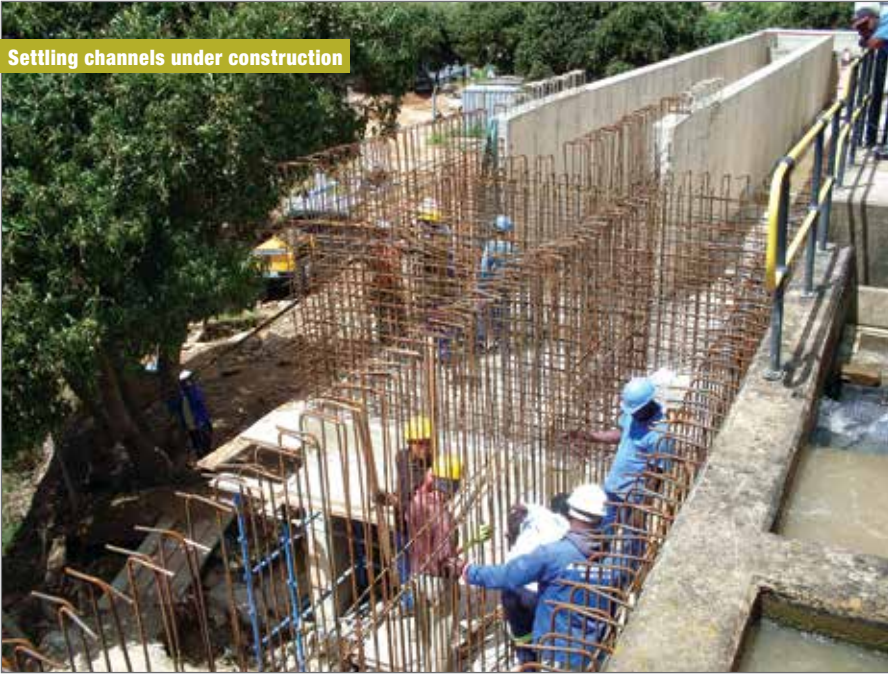
Settling channels under construction

The civil contractors constructed an additional pair of raw water settling channels for sand and grit removal to operate in parallel with the existing pair of channels feeding the high-lift pump station.

As excavation proceeded, the design and construction of the settling channels' foundation columns required adjustment to suit the conditions.

- Overflow water from the existing settling channels had to be controlled while the pump station remained functional.
- Allowance had to be made for scouring overflow water.
- At this remote location constant supervision was needed to monitor the delivery of over 300 tons of concrete and 32 tons of high-tensile steel reinforcing for steel cages which went into the construction of the new channels.
- Limited available space on the ledge.

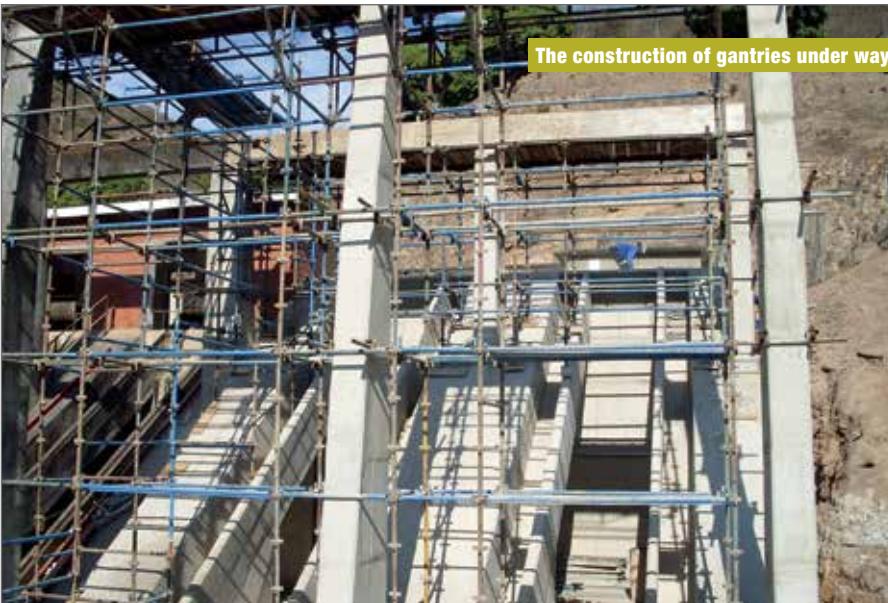
The construction of gantries under way

The various gantries and cranes servicing the pump station were required to be extended, upgraded and equipped. The crawl beam involved a 10 m long extension of the lower gantry on the low-lift structure, 11 m high columns with 31 kg/m capacity and a 4 m extension on the upper gantry.

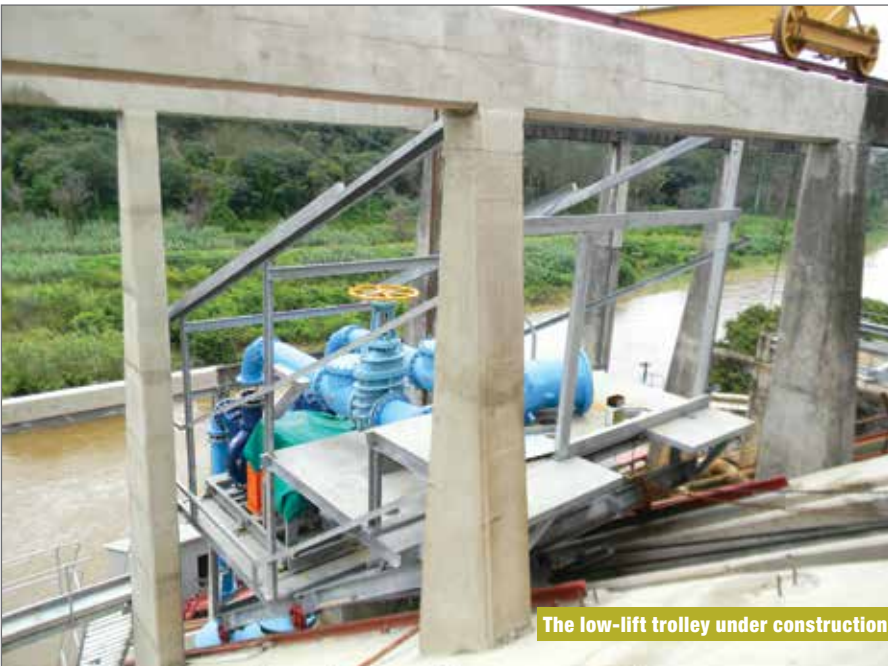
The low-lift trolley under construction

The new low-lift facility included two 90 kW self-priming pump sets (each with a duty point of 270 l/s x 22 m head) with associated suction and delivery pipework, valves, electric power cabling and controls. All this was mounted on a fabricated steel, rail-mounted trolley with an aluminium-clad steel-framed enclosure.

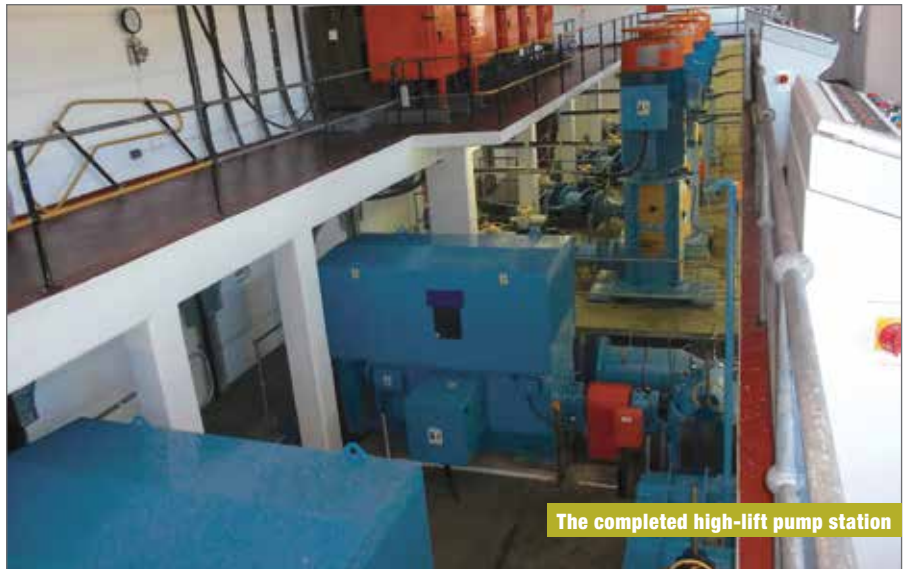
The completed high-lift pump station

The existing 200/250 GME horizontal split casing pumps were replaced with four new 3.3 kV x 600 kW pump sets. The existing concrete plinths were incorporated into the construction of the new plinths for the new can pumps. This required the cutting and removal of several tons of concrete using the new gantry crane.
